No. 4

Side-Load Coil Springs Correct Fitment

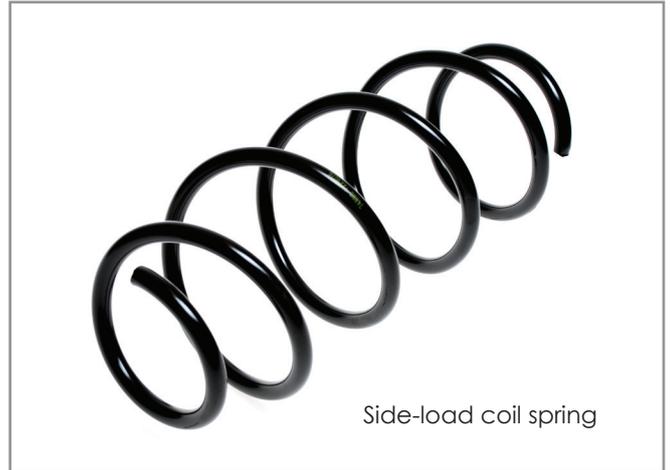
Side-load coil spring

The front coil springs on some vehicles (both OE and Lesjöfors) are of a side load design, also known as "banana" shaped.

These springs are designed to work in conjunction with the vehicle's angled top plate, which when positioned correctly will apply force in a manner which causes the spring to straighten.

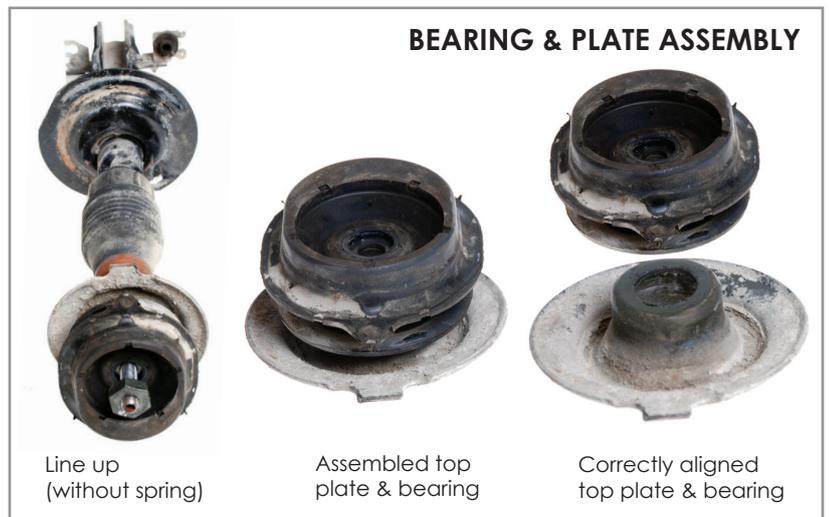
BEARING & PLATE ASSEMBLY

It should also be noted that the top plate and bearing are separate parts which can easily be taken apart and put together (if accidentally dropped they will normally split into two pieces), and that it is possible to rotate the top bearing into any position and still fit it to the top plate.

Line up
(without spring)

Assembled top
plate & bearing

Correctly aligned
top plate & bearing

It is therefore important to check that the plate and bearing are lined up correctly.

To do this the rubber tag on the top bearing should line up with the slot in the top plate, which in turn should line up with the bottom end fitting of the assembled strut.

If fitted correctly, as detailed above, the spring will straighten once force is applied to it.
